Refurbishing the front brakes on a Citroen H Type van

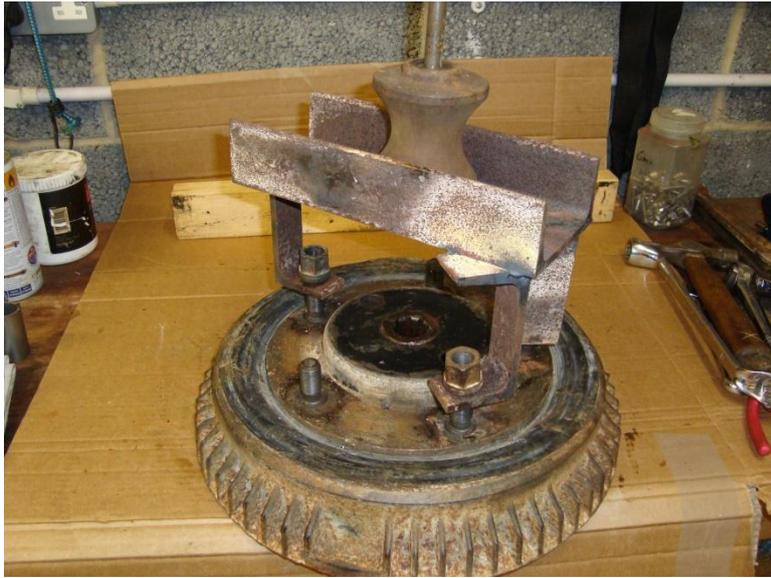
inside. You will need to make a puller. As you can see mine is made of sections of steel channel welded together with a long steel rod threaded and nutted at both ends and a sliding weight. Attach it on three wheel nut locations and bang away until the drum comes free with its bearing. The splined drive shaft will become loose at this point and the universal joint will allow the shaft to be pushed back. This is important in order to remove the pinch bolts that

hold the hand brake levers in place. It would have been easier if the engineers at Citroen had put the nuts on the pinch bolts on the inside so that the bolts could be drawn out easily. You will see what I mean when you come to undoing them. On my first attempt I cut the heads off the bolts with a hacksaw blade until I realised that with sufficient wangling the universal joint could be moved sufficiently to withdraw the bolts. It can just be done if the handbrake arms are loose as well. Tap the arms off and the springs will jump off as they come free. There are two bolts retaining the bottom cylinder which need to be removed. There are also two others, a large one on the top centreline with a folded tab and a smaller one on the bottom centre line these need to be removed too. The brake pipe is easily disconnected but to preserve fluid undo the reservoir and place a piece of plastic over the opening and screw the cap back onto seal out the air. A small amount of fluid may be lost but the vacuum thus formed in the reservoir saves most of it. At this point everything should be free for the whole assembly to be prised off the hub.

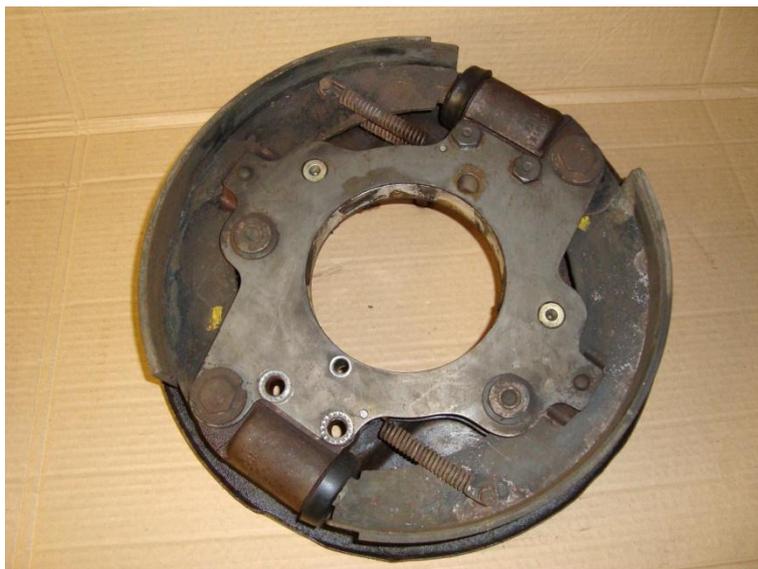
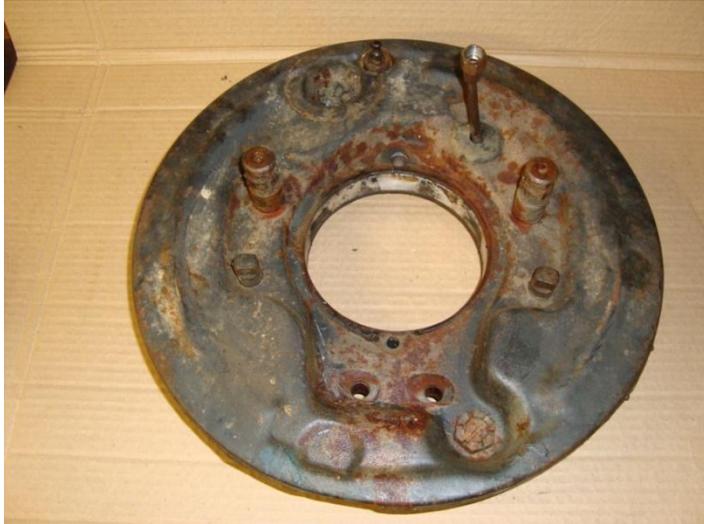
The following two pictures show the shoe side and reverse side. On the shoe side the springs can clearly be seen. The circular shapes of the eccentrics are located adjacent to the cylinders and on the reverse the castellated nuts and split pins that hold them in place. One of the nuts is in a deep recess so the split pin has to be removed by bending and pulling. Undo the nuts and tap out the eccentric retaining bolt but be careful not to damage the threads.

Remove the two bolts that hold the top cylinder on and the two plates will come apart. Watch out for the small spring retainers just under the cylinders between the plates.

The splined shafts of the hand brake mechanism can be seen on the reverse side as can the brake adjusters. As the assembly is dismantled the splined shafts will come free. The actuating lobes have a wheel held in with a loose pin. Note which way the lobes are as the mechanism is handed. Take this opportunity to clean everything. Apart from the cylinders and pistons I have used a handful of washing powder dissolved in boiling water and a scrubbing brush to get rid of

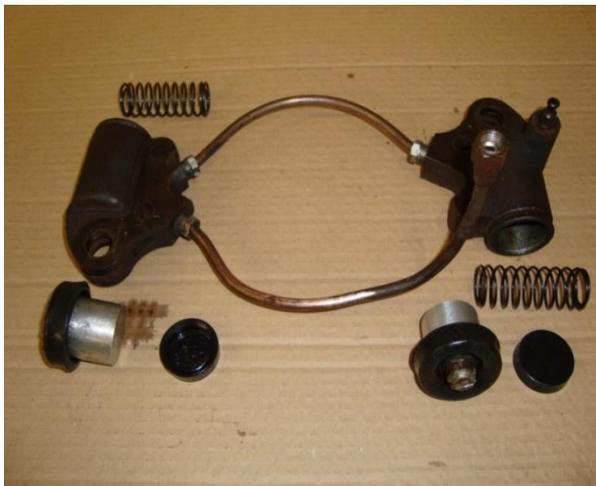
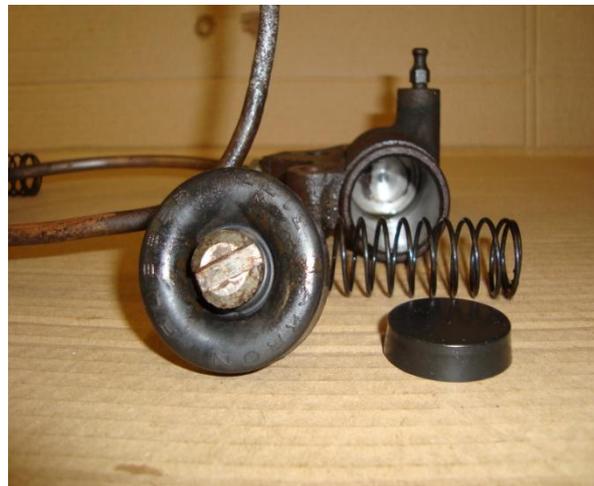
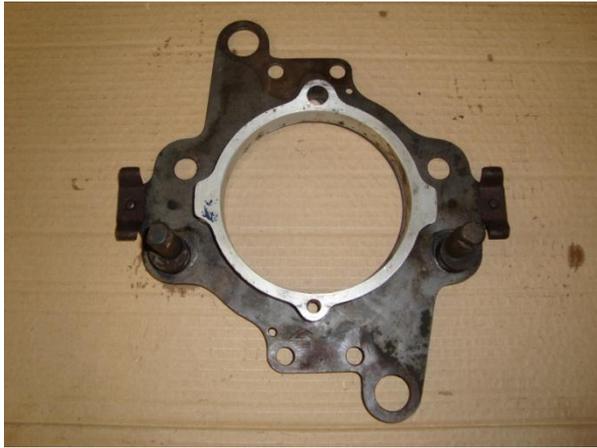
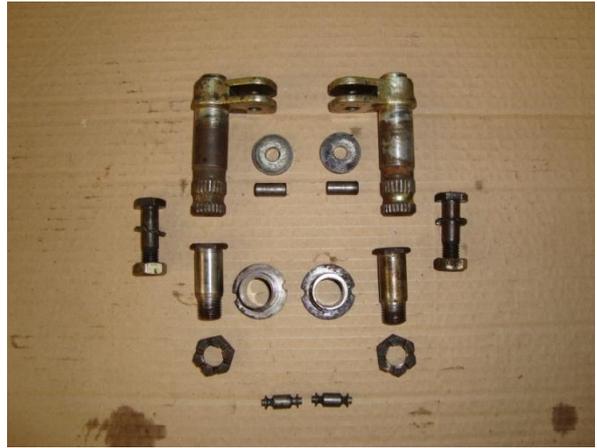
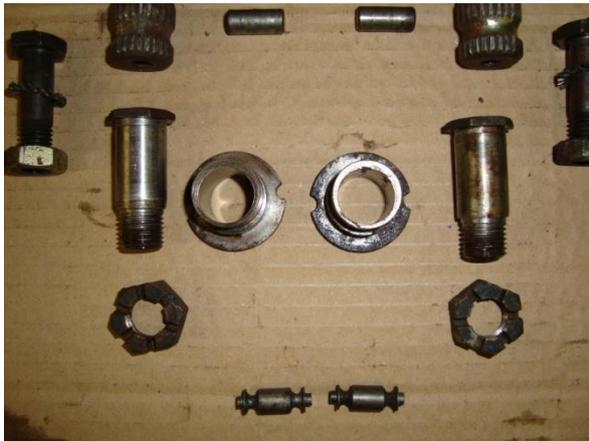
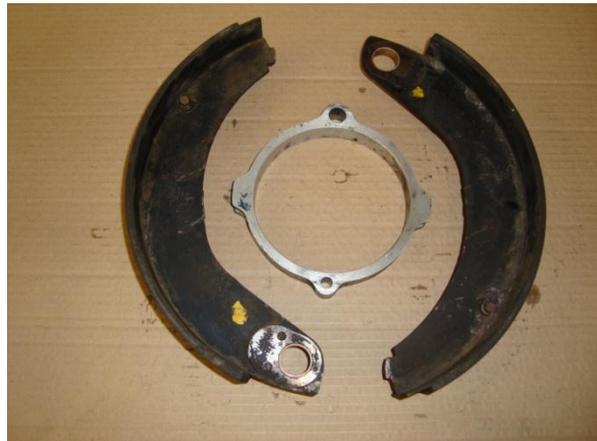
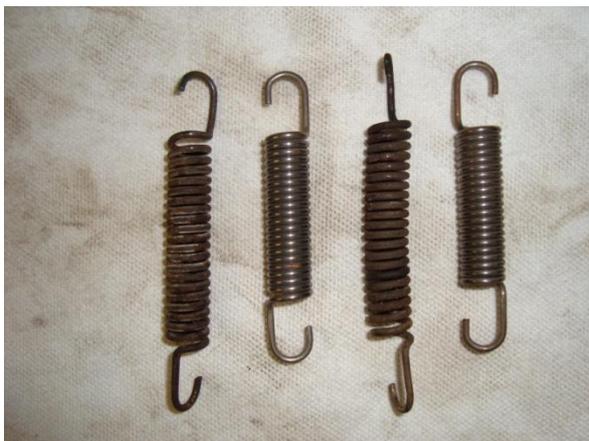
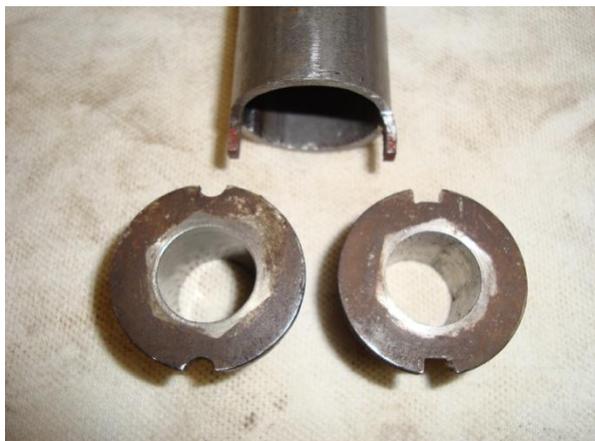
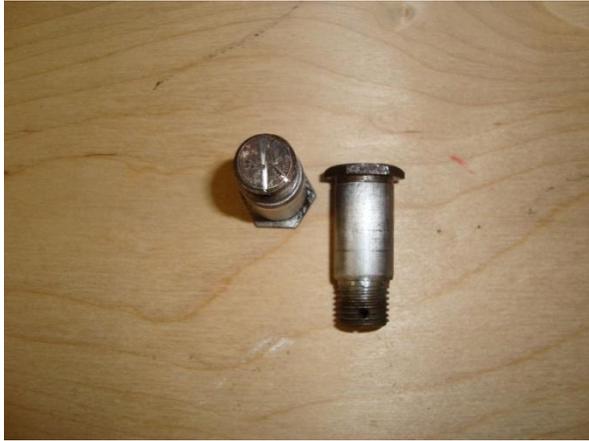
The following photographs show the different parts after they have been cleaned up. The pipe joining the two cylinders looks like copper but it is in fact copper coated steel. Replacement copper units can be obtained from Jeff Winterman. The pistons and the cylinders were cleaned with fine wet or dry paper to get rid of the lacquer like build up which prevents the proper function of the system. Clean thoroughly with brake fluid and blow out with the airline if one is available.

The small bobbin shaped things at the bottom of the picture on the left above are the spring retainers and in the middle are the eccentrics and their bolts. The brake shoes above right have bronze inserts in their pivot holes – a nice touch. The new retaining springs are shown alongside the old ones below. The eccentrics have semi-circular cut-out for a special tool to adjust them. I found it easier to file the cut-out into a square and make up a new tool to fit from a bit of steel pipe as shown below right.

It is helpful to put a saw cut in line with the hole in the eccentric retaining bolt so when you come to reassemble the whole lot, you can judge where the split pins go without resorting to a magnifying glass especially if you are working alone and have to hold the assembly. To get the pins through the slot of the castellated nut in that part of the backplate that is deeply recessed you will need to fold the end of the pin first to engage it and follow this with a screwdriver to push the pin down and in. Repeat this

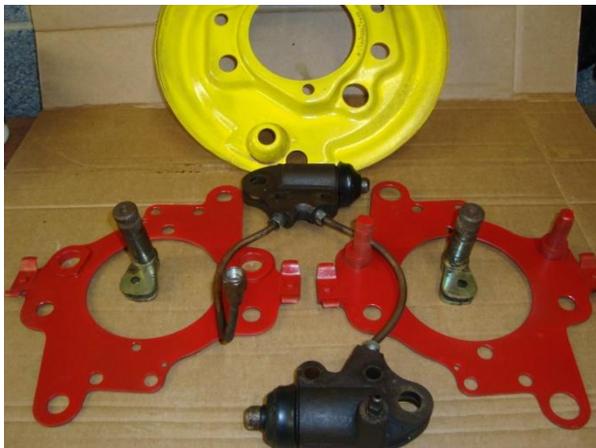
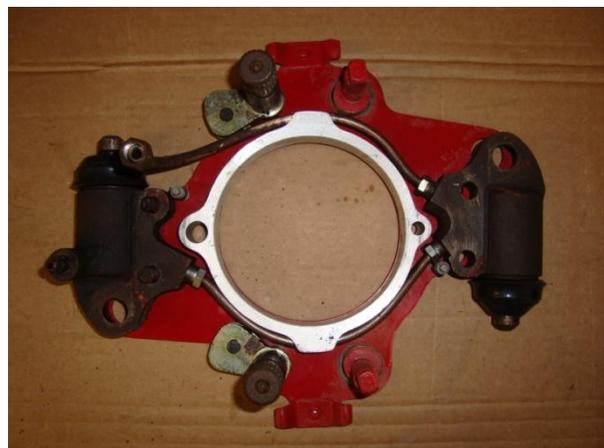
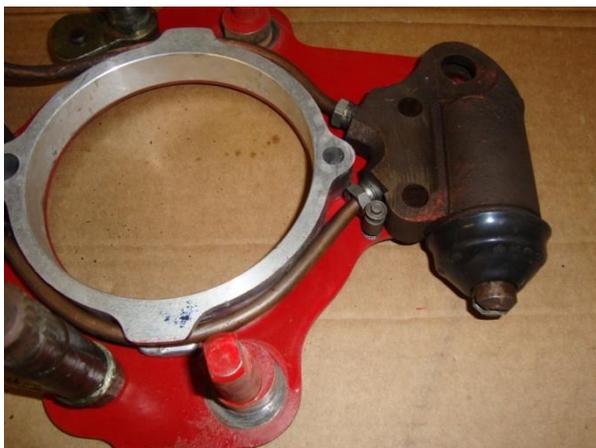
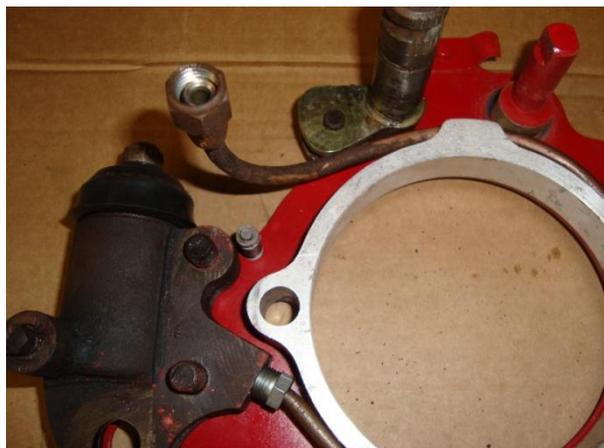
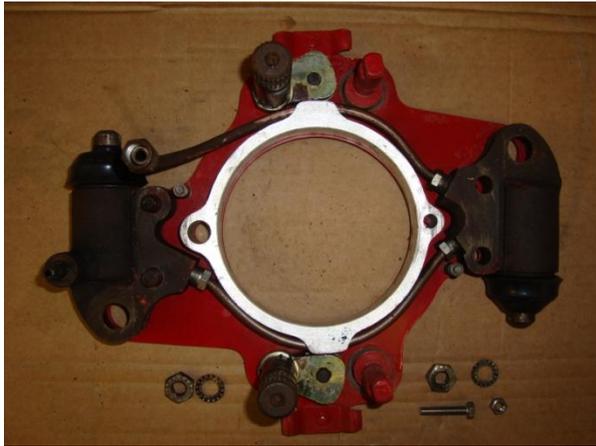
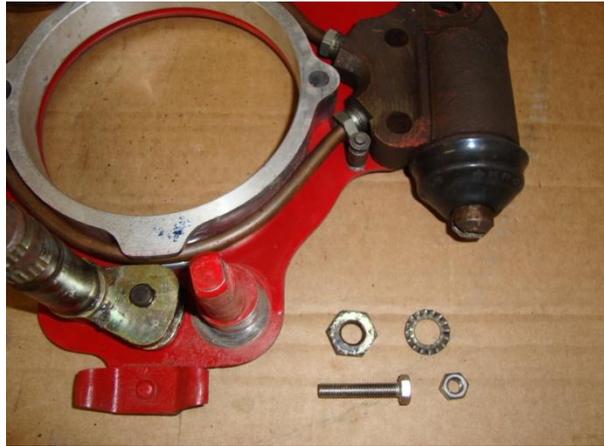
several times until the pin is fully home and can be bet back over the nut. The following series of photographs show the assembly at various stages. I found it easiest to working from the back and building towards the front but putting the back plate on last.

Note the spring retainers snuggling beside the cylinders. They fall out with devilish regularity! Best to have a clean old sheet or something similar to work on to catch the parts that tend to fly off when least expected.

The brake pipe that wraps around the central aluminium spacer does tend to get bent out of shape when you are taking things apart and becomes a real problem when trying to connect up again when the assembly is bolted back to the hub. Be careful not to bend it too much.

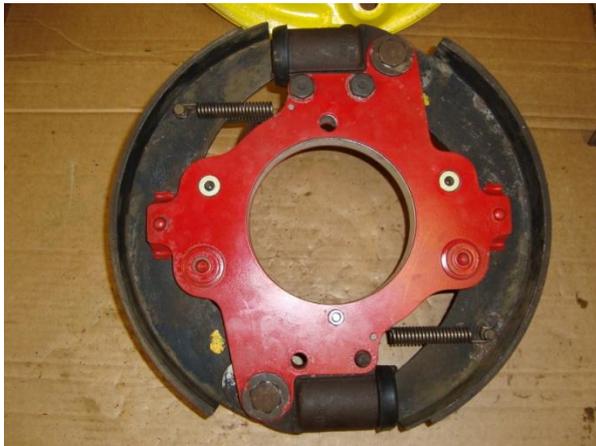
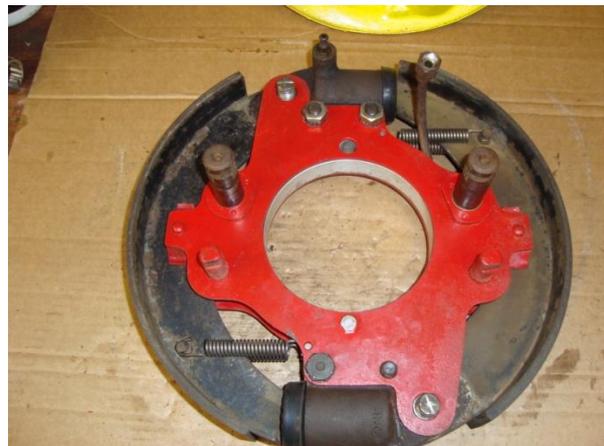
The following two pictures show the assembly from the front on the left and back on the right. It is best to fit the eccentrics and their bolts without the return springs in place. It is quite a fiddly job getting everything to line up and free to move. Do not tighten anything apart from the nuts that hold the top piston in place. I used a small nut and bolt to hold the pieces together just above the bottom piston until the eccentric were tightened.

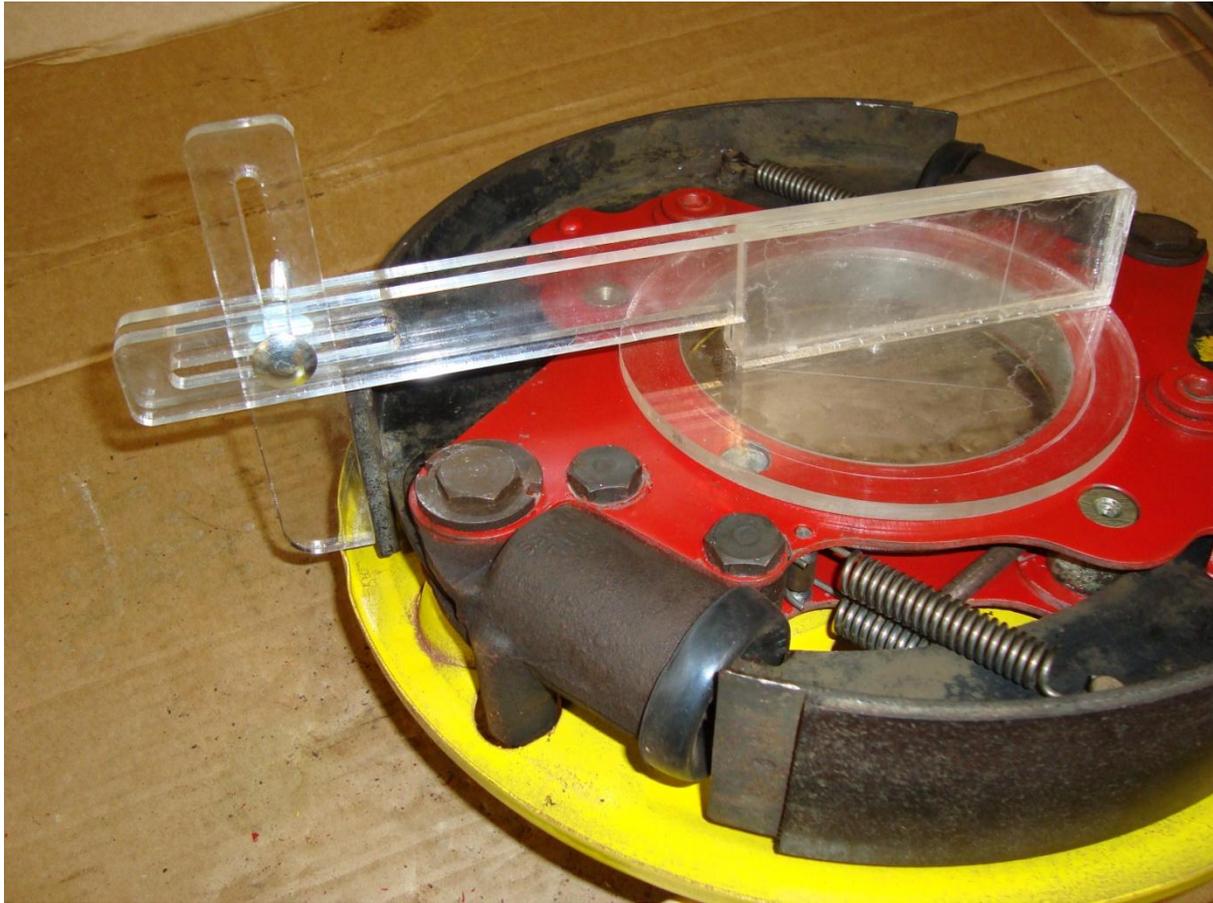
I made this centring tool from Perspex and used it to set the pivot end of the brake shoes to be the same by using the eccentric to adjust movement. The adjusting cams on the back of the assembly are turned so that the shoes are released.

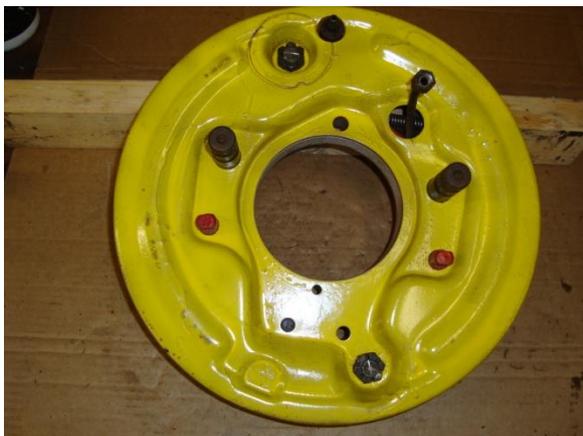
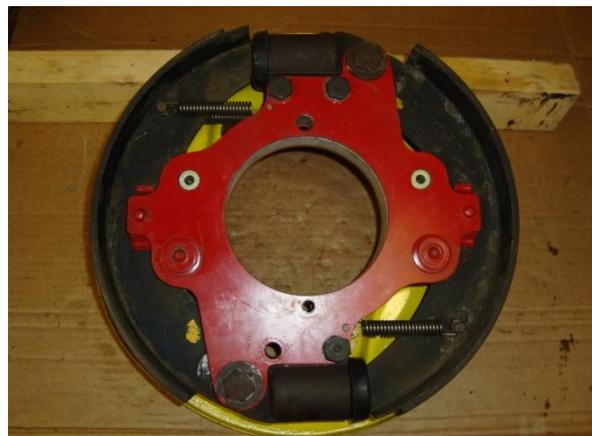
Below is the complete assembly ready to be bolted onto the hub. The deep recess with the nut from one of the eccentrics can clearly be seen. The bottom piston has two bolts which fix into the hub, likewise the hole under the top piston.

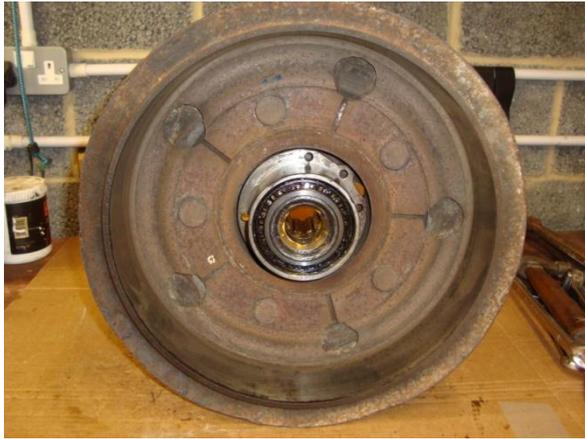
The brake drum from the inside showing the large one piece bearing. This was quite difficult to get back on once the brake assembly had been bolted up. After hammering to no avail with a wooden mallet I bolted up the puller I made and used it in reverse. Make sure the splines from the drive shaft enter the bearing before you try to bang the drum on too far. Once enough of the threaded section of the drive shaft protrudes, use the retaining nut to finish pulling the shaft through and forcing the

drum into place. I had to bolt up the six smaller bolts as well before the drum was fully back into place. The brake fluid pipe was teased back into position and the brakes bled. At this point everything was working just as I had hoped. But you never can tell with a H van !!!
